AIR FORCE PACKAGING EVALUATION AGENCY WRIGHT-PATTERSON--ETC F/G 19/2  
VIBRATION TEST OF AN ACA-305 CONTAINER FOR BL-755.(U)  
MAR 77 P QUIJAS, E P MORAVEC

12  
B.S.  
PTPD REPORT NO. 77-14  
AFPEA PROJECT NO. 77-P7-5 ✓

VIBRATION TEST OF ACA-805

CONTAINER FOR BL-755

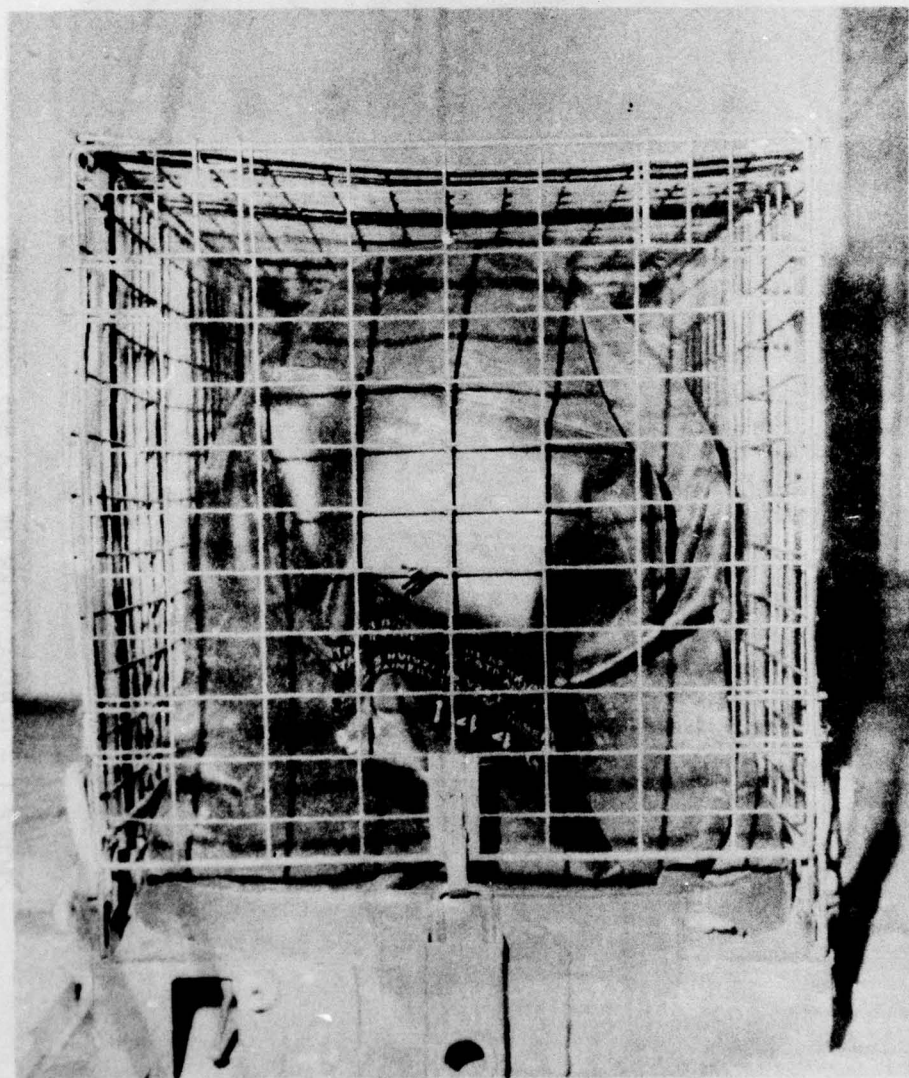
FIGURE 2 - END VIEW OF PROTOTYPE AS RECEIVED

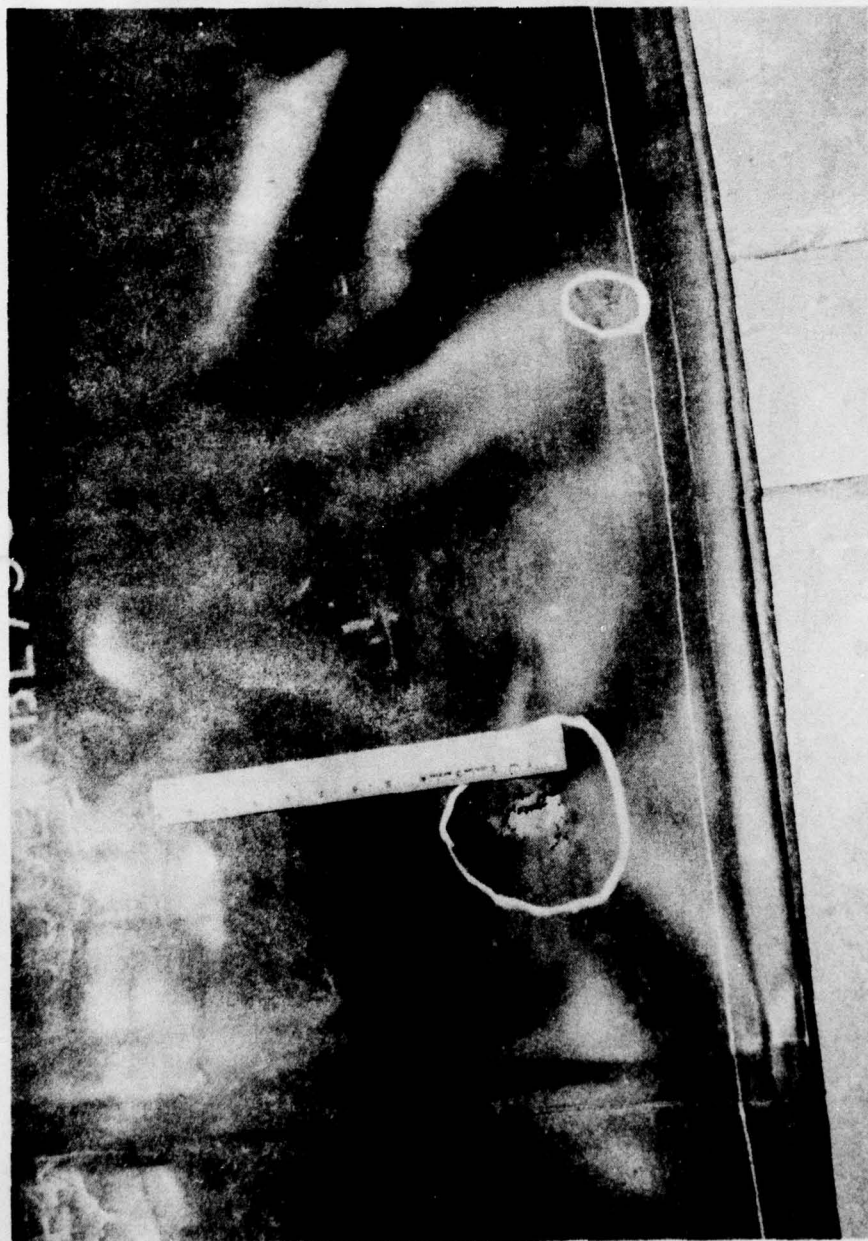
VIBRATION TEST RESULTS: As a consequence of the vibration test, several holes were abraded through the rubber bag. There were six holes along the bottom of the bag within 7 1/2 inches from the existing white line; five holes on the right and one on the left side. One other hole was located on the top at the rear of the bag. The largest hole was one by two inches on the right side as illustrated in Figure 4.

FIGURE 4 - HOLE ABRADED IN BAG

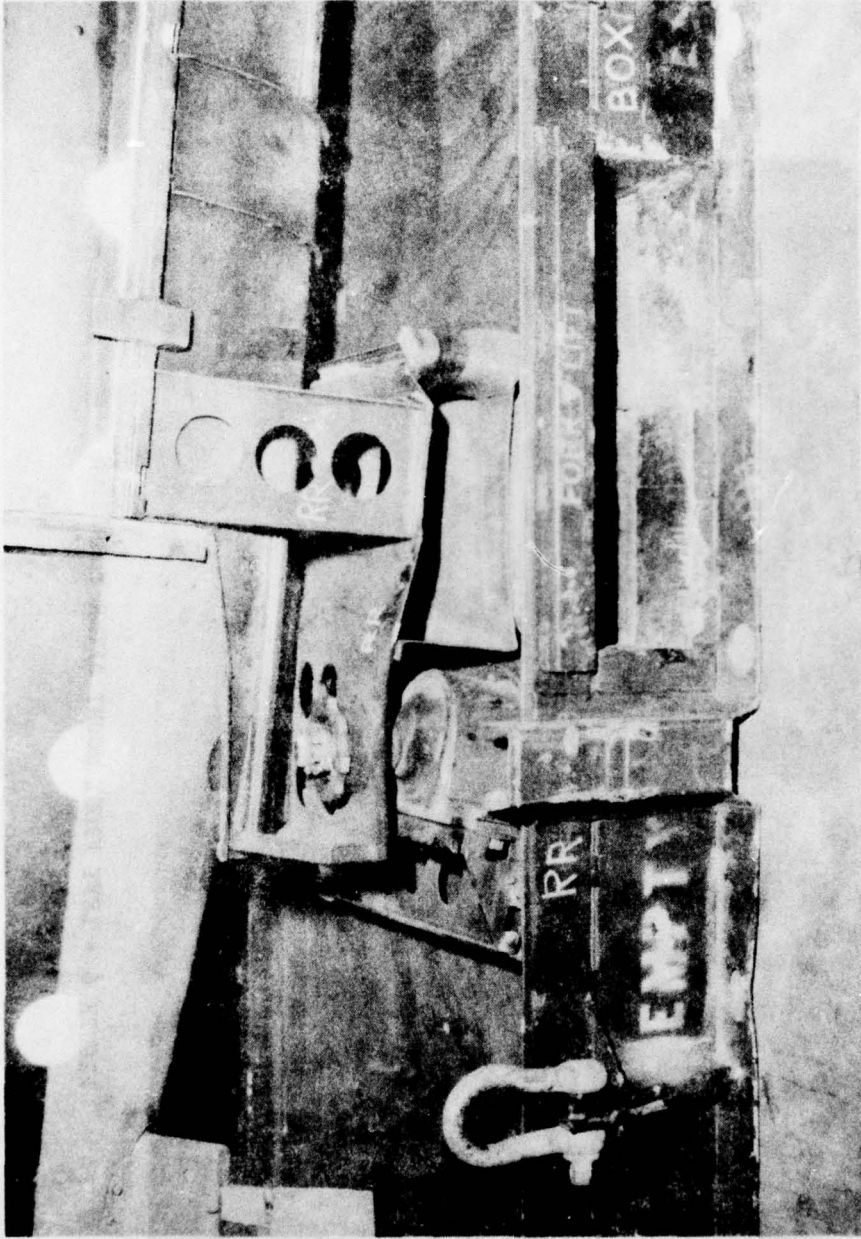
The shock suspension and the sheet metal suspension supports failed. The rear sheet metal suspension support was generally shattered, deformed, and near collapse as shown in Figure 5.

FIGURE 5 - RIGHT REAR MOUNT AFTER VIBRATION

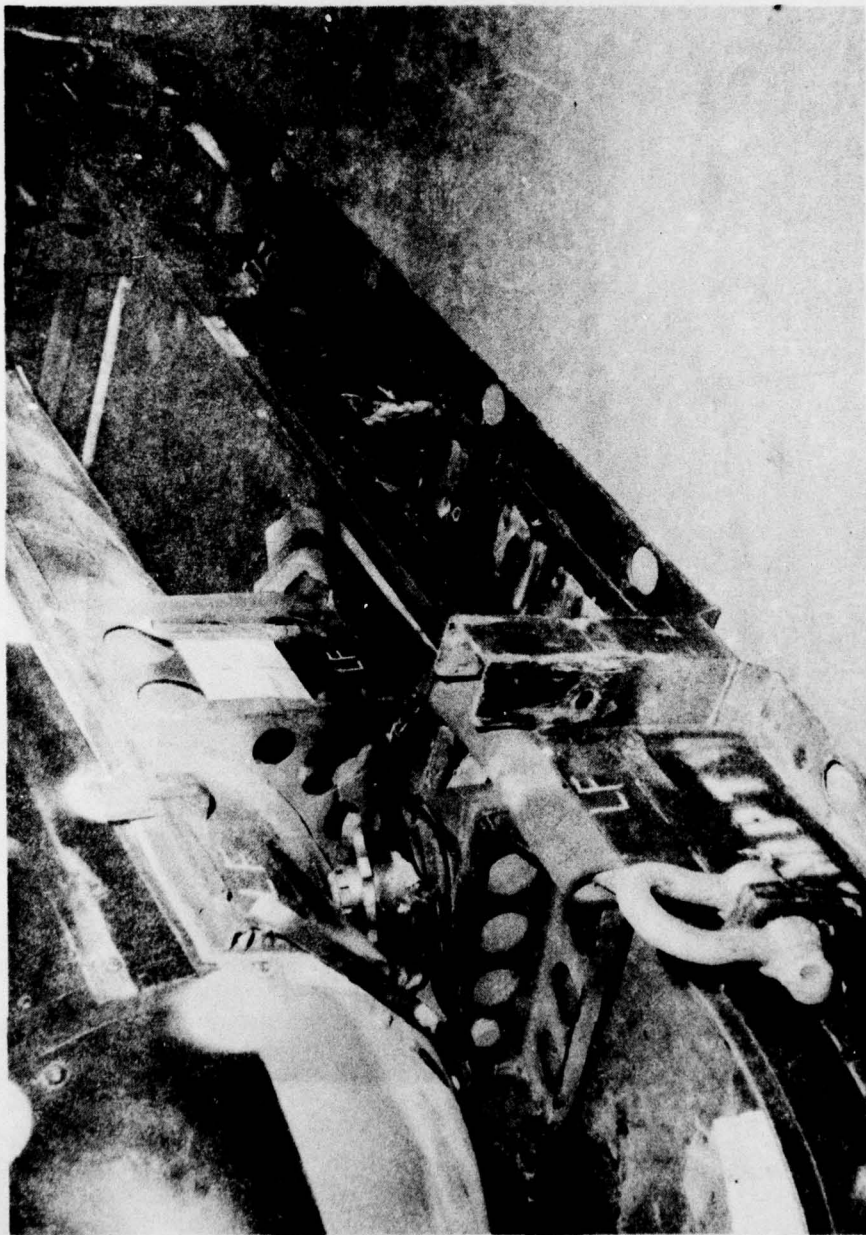
The front sheet metal suspension support was completely collapsed so that the left and right vertical shock mount pins had abraded the underside of the cradle and had significantly dented both the cradle and the BL-755 item skin. These conditions are shown in Figures 6 and 7. A general view of the BL-755 and mountings after vibration test is shown in Figure 8. The apparent under design of the suspension structure, the heavy load reaction at this point, and the observed initial buckling (see initial inspection) are considered to be factors contributing to total collapse of the front suspension system. Generally, the rubber in the shear isolation mounts incurred rubber metal bond failure and tearing of the rubber.

FIGURE 6 - - LEFT FRONT MOUNT AFTER VIBRATION

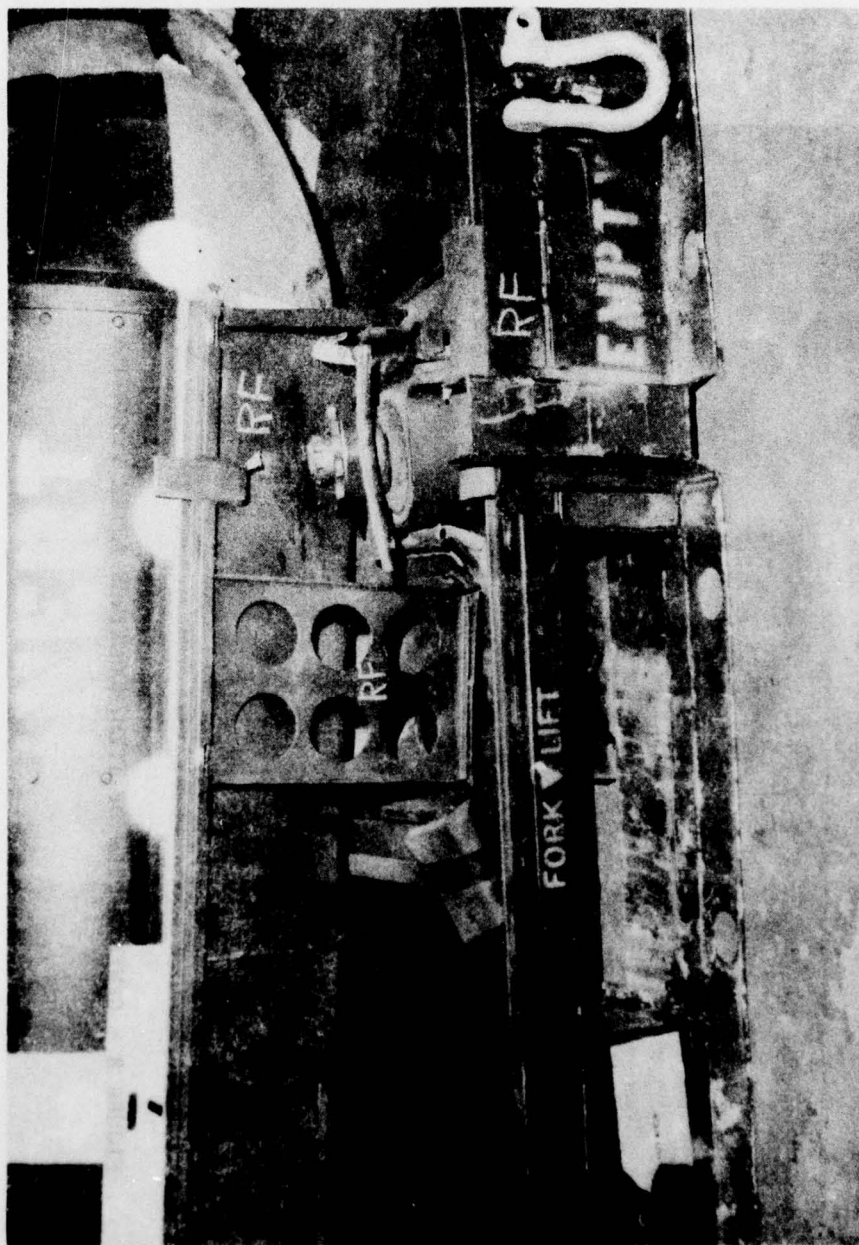
FIGURE 7 - RIGHT FRONT MOUNT AFTER VIBRATION

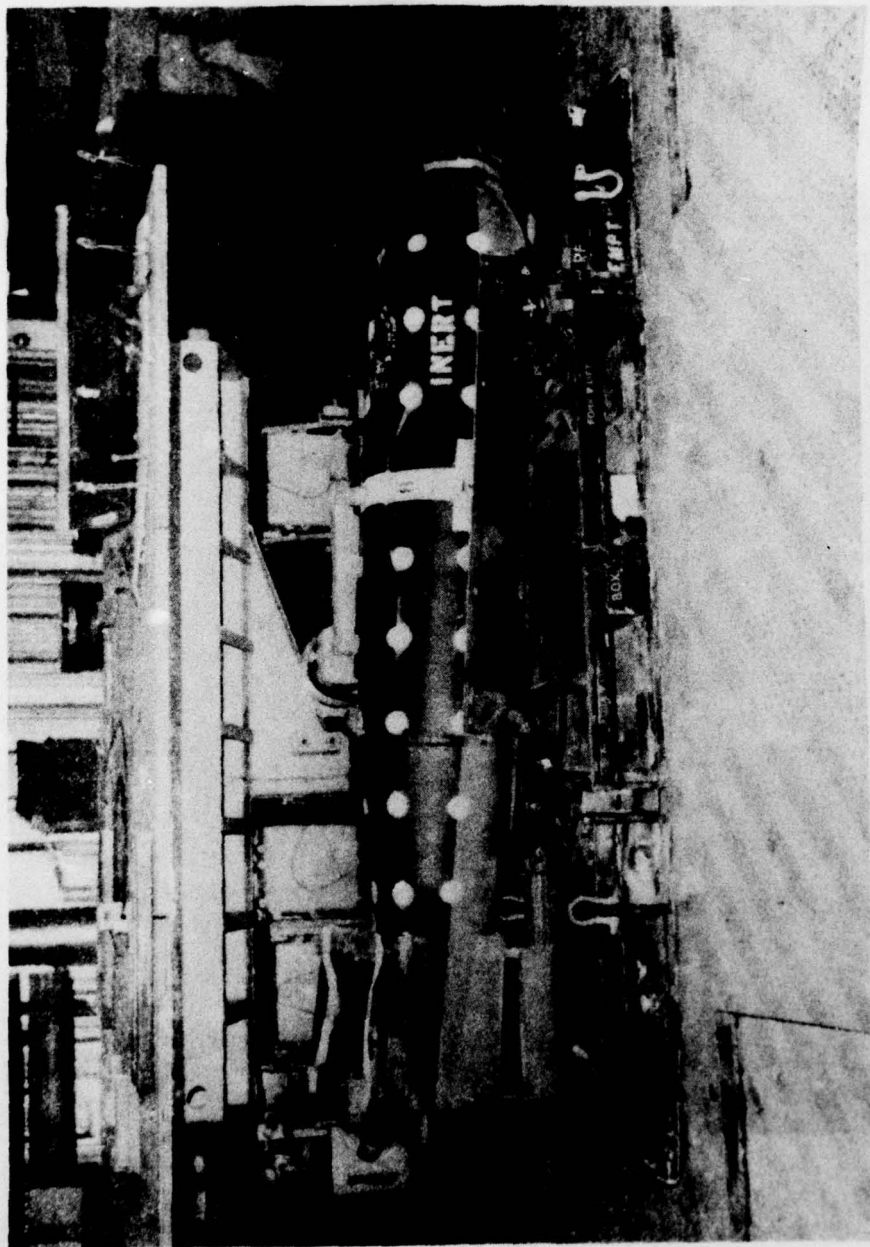
FIGURE 8 - GENERAL VIEW OF ITEM/MOUNTINGS AFTER VIBRATION

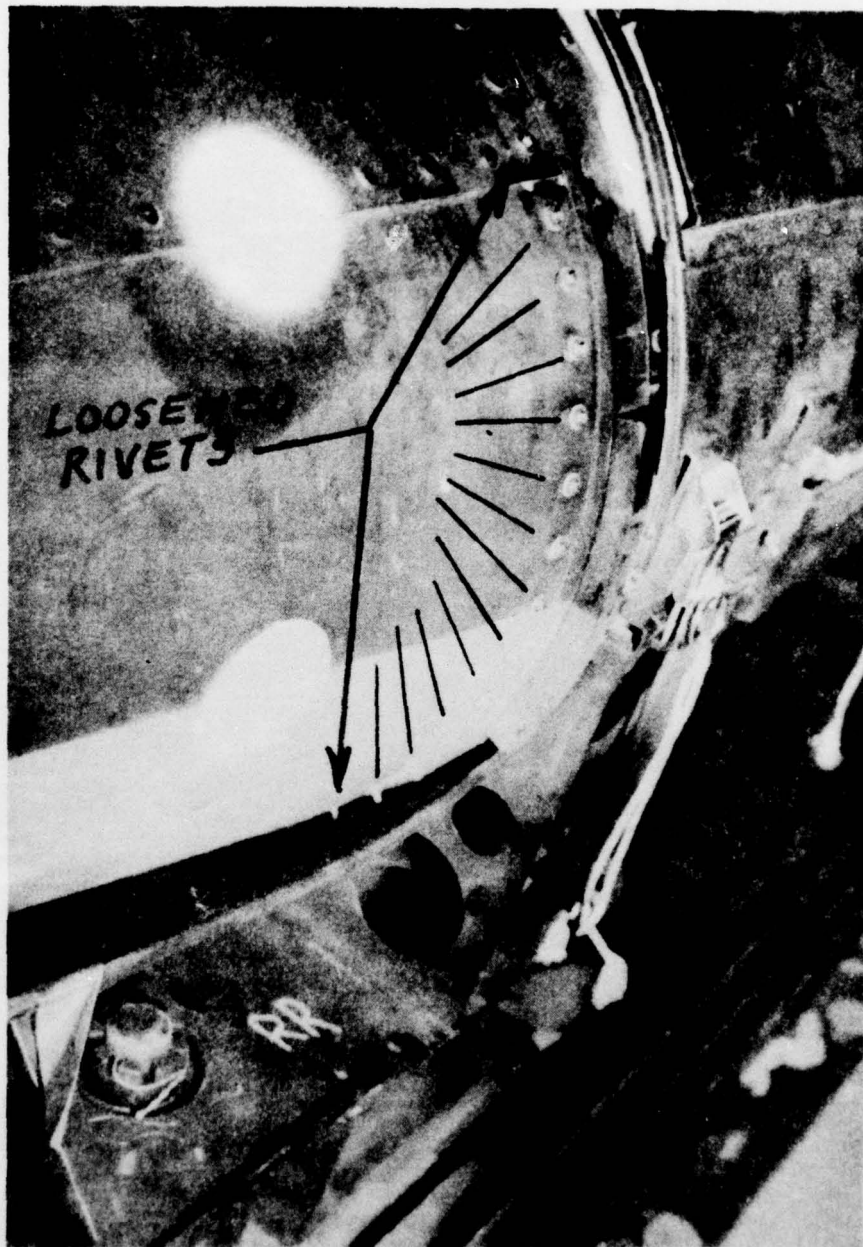
The red flagged retainer pin which inserts into the rear of the lower left fin was sheared. It is believed that this allowed only a little more hammering of the fins since there was already some movement prior to vibration with the pin apparently in place. The aluminum tube which protrudes from the tail of the item when the fins are extended, was abraded/cavitated on three quadrants by the hammering action of the fins. Other surface abrasion was noted on the end of the tube. On the lower right quadrant where the tail of the item is joined to the body, several blind rivets failed as evidenced in Figure 9 by the core stems protruding from about 16 of the rivets.

FIGURE 9 - LOOSE RIVETS ON BL-755

It is concluded that the ACA-805 prototype does not meet the established requirements and is not suitable for Air Force use. The fins on the BL-755 item are not adequately secured to prevent internal damage during handling and shipment. To preclude movement of the fins it is suggested that the fins be encircled twice around with nylon reinforced pressure-sensitive tape to hold them firmly in place.
